Manhole Inspection Summary

Manhole # S09Y__002MH

Insp Date: **4/22/08 2:27 PM**

Location Address: **1229 PINE Heights**

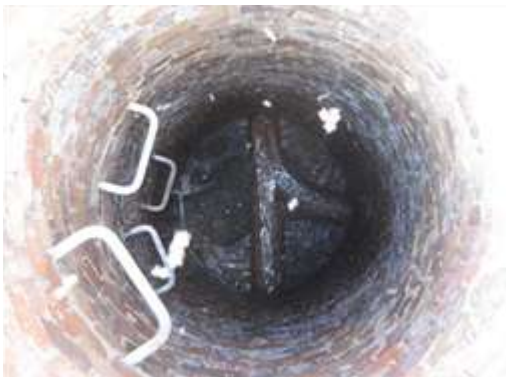
Top View

Comments **unable to get measurments for 9 - look at picture..**

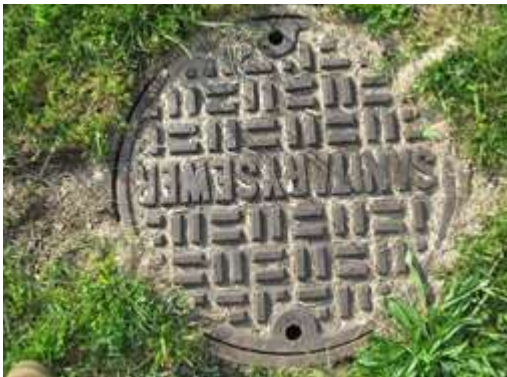
lid pic

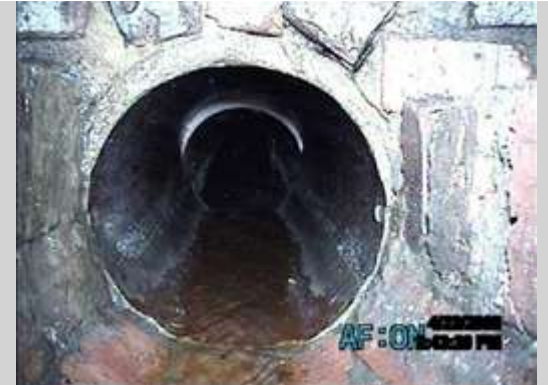
12 O'Clock Outflow

8 in. Circular Gravity Sewer
Pipe Out @ 12 O'Clock

Pipe Height: **8.4** (in.) Rod and Bar (Angled)
Pipe Material: **Clay** ☐ Pipe Lined
Invert Depth: **11.85** (ft.) Flow Characteristics: **Fast**
Deposits: ☒ None ☐ Mud ☐ Sludge ☐ Debris ☐ Grease
Silt Depth: **0** (in.) Deposits Extent:
Infiltration: **None** Pipe Seal Cond: **Sound**

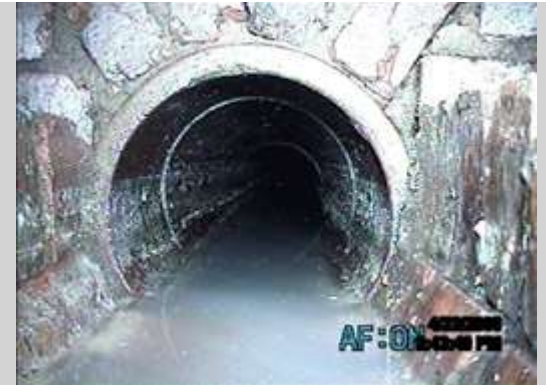
6 O'Clock Inflow

Pipe In @ 6 O'Clock

Pipe Height: **8.4** (in.) Rod and Bar (Angled)

Infiltration: **None** Pipe Seal Cond: **Sound**
